BUILDING TYPE BASICS FOR

museums

JACK AND BELLE LINSKY GALLERIES, METROPOLITAN MUSEUM OF ART, *New York, New York*

MUSEO DE ARTE DE PUERTO RICO, *Santurce, San Juan, Puerto Rico*

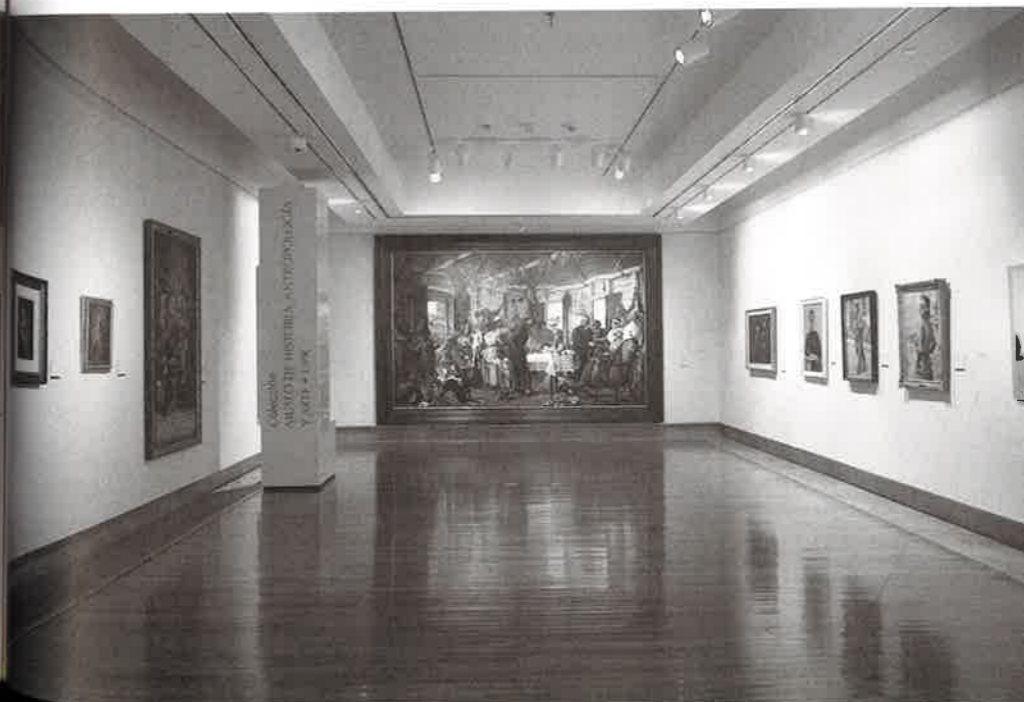
▼ Typical gallery soffit lighting details. Note indirect fluorescent light source within soffit. Where necessary, ductwork can be enclosed in soffit, as shown in detail on right. Light track is recessed in bottom of soffit.
